Scaling New Heights

Preventing falls in the air transport industry

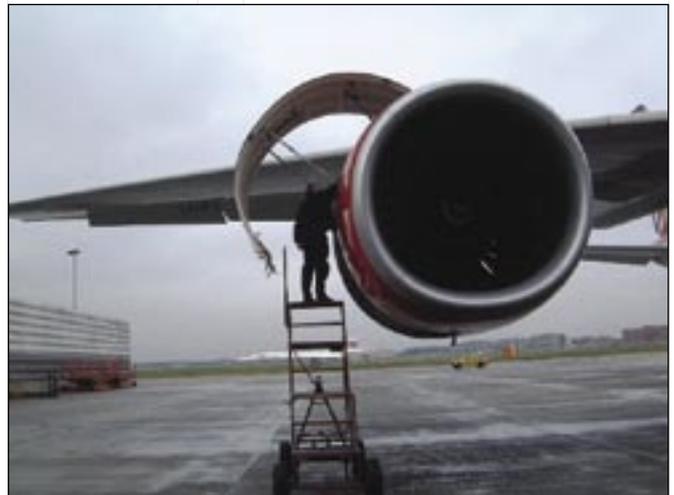
Figure 1. Original steps

When it comes to aircraft maintenance, the industry has used one particular design of steps for all tasks for the past 20-25 years. They are very versatile and allow access into, under and around the aircraft engine, along with access to the cargo hold. From a safety point of view, however, the design is poor. The employee can be working nearly 2.5 metres off the ground, with little or no protection from falling and when accessing the cargo hold, a large unprotected gap is left. Virgin's own accident statistics showed that over a four-year period we had 11 working-at-height lost time accidents (with 10 of these involving access steps). One of these accidents almost resulted in a death. These accidents resulted in a significant number of lost working days, to the extent that, in 2004, we decided to look at the step design and try and find a better solution.

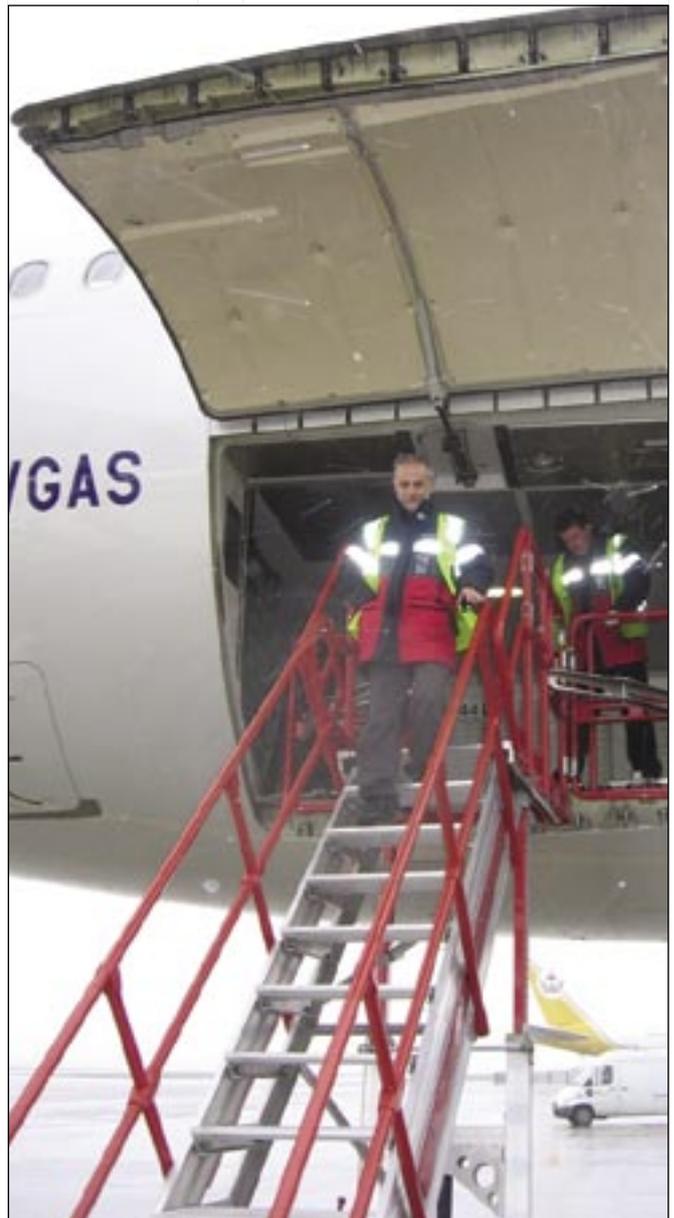
Figure 2. Cargo bay access steps

Version 1: cargo-bay access steps

We modified the top of the steps with swing-out adjustable gates. The result was a lightweight, easily manoeuvrable, height-adjustable set of steps capable of giving total protection to those working in the cargo hold. Also, because both the swing out gate and the height were adjustable, they could be fitted to all our aircraft types. ►

We trialled the steps and they were very successful with the engineers - not only at the cargo hold but also for other jobs. They could also be used under the wing and over the engine, which meant they could also be effective for a range of other maintenance tasks.

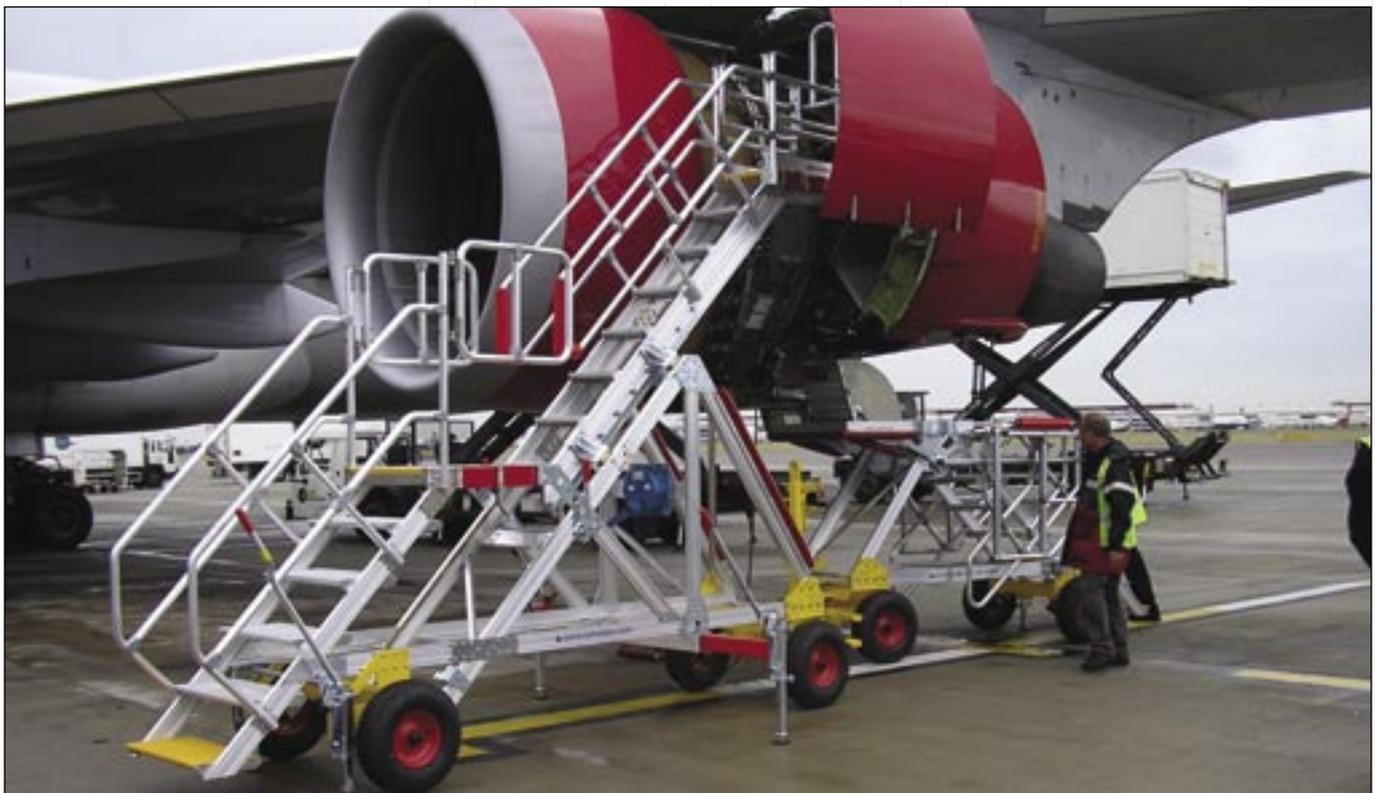
Figure 3. Engine access steps

Version 2: engine access steps

The feedback was positive, as these steps provided a flexible, safe working platform up to 3.2 metres, allowing full access for two engineers under the engine cowls and around the outboard engines on the A340-600. The design incorporated folding railings, allowing better access while maintaining the engines, while the platform and access steps had excellent protective padding, preventing any accidental damage to the aircraft while manoeuvring the steps into place.

They were also height adjustable (they can slide to a height of 1.5, 2.5 and 3.2 metres), which meant you could get to the inboard engines as well. The mid-platform also gave good access to the front of the engine, to check the fan blades.

We had solved one problem, but it was clear that one solution was not going to solve all problems. So we went back to the supplier and showed them the problems we had. We revealed the areas we wanted to be able to get to - the front of the engines (to access fan blades) and underneath the engine (the engine cowls). This is a very limited space - there's a lot of equipment around you, so it's quite difficult to get access steps that fit in this space and that are fully compliant with both the legislation and the EN standard.

They came up with a design and manufactured a set of trial steps. We put the steps on trial and handed out feedback forms to the engineers. Following their feedback, some modifications were carried out and the steps put back on trial.

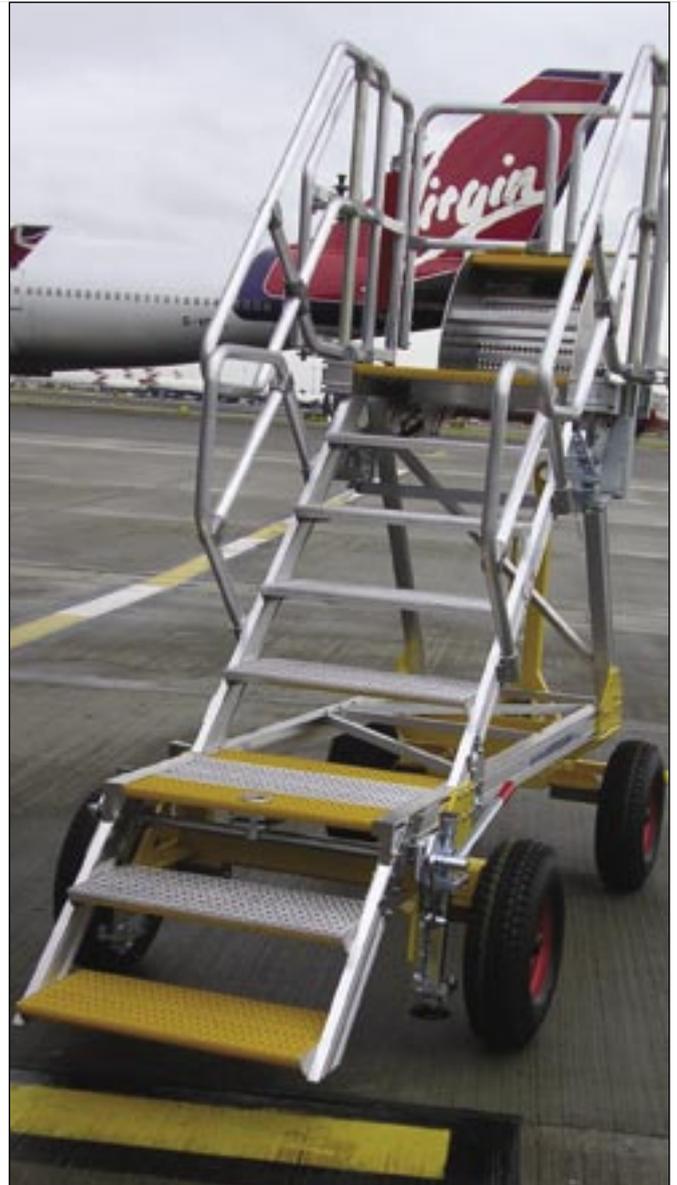
Figure 4. Fixed height steps

Version 3: fixed height steps

So this third set of steps was for general use - quite versatile, lightweight, based on the same footprint as the old steps, but compliant with the regulations and the standard. They gave good access under the engines and outside the engines to top up the oil on turnarounds. The principle was that when you are under the engine you would be protected, because you have the engine on one side of you and the cowl the other side. So when you put the step under the engine you're protected by the structure of the aircraft.

So we trialled the new general purpose steps and they seemed to fit the task. The supplier also made a small extendable 'hop up' inside the steps to get a bit more height - an extra step that pulls out of the top step, that can be used when you're right inside the engine. These steps can be extended to fit just about any space in our three types of aircraft. So we now have three sets of steps fit for purpose - cargo access steps, height adjustable steps for special tasks requiring access to difficult-to-reach areas, and a set of steps for everyday tasks such as engine oiling. We also included a small set of hop-up steps that can be towed behind the everyday steps for even greater flexibility.

went back to the drawing board, and the supplier came up with another design using the same template as the existing steps, but we had to 'stretch' them slightly so they complied with the new standard. And in order to meet the new health and safety specifications, Semmco added some adjustable hand rails too.
